Cascade View Elementary Walking Audit

King County Public Health

Cascade View Walking Audit

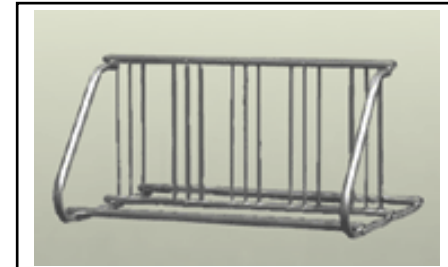
“Wheel-bender” racks (above) can damage wheels and don’t allow frames to be locked to the rack.
