Muir Elementary School “Green Feet Project” Walk and Bicycle Audit

Muir Elementary Green Feet Project / Mt Baker Neighborhood, Seattle

Walking Audit Field Notes

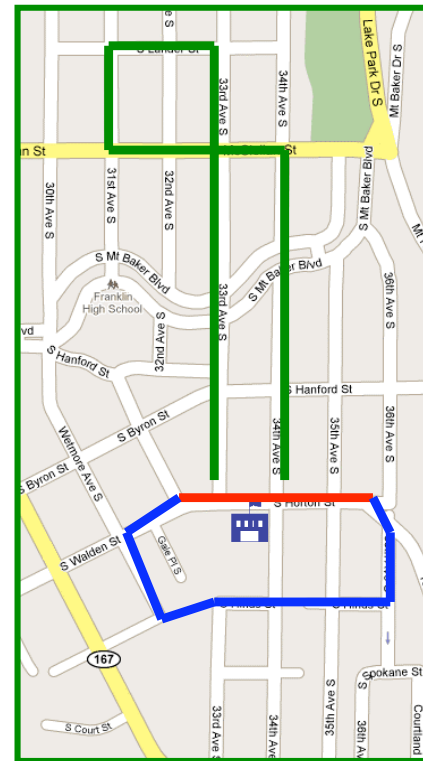
Map of Walking Audit Route

Audit route: The group began by walking along S. Horton Street for 3 blocks directly in front of the school. The group broke into two groups; one circling the school on foot to the south and east, and the other traveling by bicycle on a one-mile loop to the north and west.

Red = whole group
 Blue = walk route
 Green = bike route

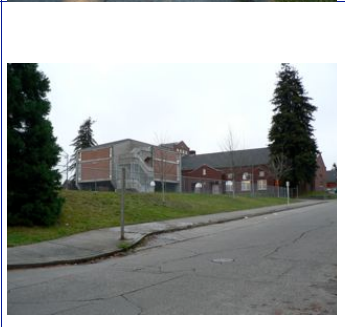
<p>6</p>

<p>33rd S. below S. Horton</p>	<p>Buses drop off on this side of the school. The system works best when the buses proceed all the way to the curb indent by the playground. Participants explain that private vehicles also use this drop off occasionally, but that otherwise the system seems to work well. In this way, Muir has followed the most important rule for school bus zones, which is to separate bus load zones from other modes of travel, both vehicular and pedestrian. Participants emphasize again how important it is that the crossing guard helps to enforce this rule.</p> <p><i>Note: an observation of the area during school drop-off time showed that this space is used more than previously thought for drop-off and pick-up. In addition, the driving behavior noted here was more dangerous to pedestrians than at other locations, with numerous U-turns and mid-block crossings noted.</i></p>

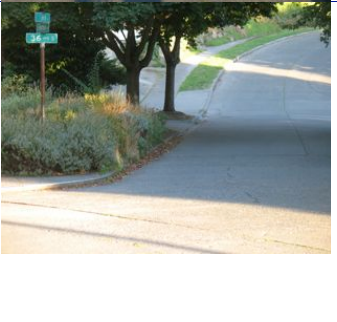
<p>10</p>

<p>S. Horton and S. York See recommendation # 3</p>	<p>This intersection causes a great deal of concern for the school community. In particular, people observe very fast speeds from drivers traveling down S. York toward S. Horton, as well as in the other direction. Drivers are not cautious of pedestrians here, because the angle of the roadway makes it attractive to speed, the visibility is compromised by plantings and turns, and there is not a critical mass of people who walk, making pedestrian activity unexpected. Possible engineering improvements include stop or yield signs for York traffic, “watch for ped” signage, crosswalk painting across S. York, and an “intersection repair” (in which the community would design and paint a street mural to act as a visual reminder to slow down. The Green Feet project will seek engineering advice from SDOT to learn of the feasibility and effectiveness of the different alternatives.</p>

3. Address the traffic and pedestrian safety issues at the base of the Horton stairs.
4. Partner with law enforcement to address the problem of loitering and drug use at the Horton stairs.

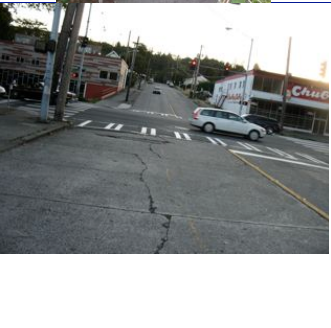
<p>20</p>

<p>Rainier S. and S. Horton See recommendation # 6</p>	<p>The Seattle Public Schools shortened the walk boundary this school year, and now provides bus service to students in the residential pocket west of Rainier S. While bus service across busy streets circumvents immediate safety issues, it is important to press for improvements so that students may have the ability and right to safely walk this quarter mile stretch to school. There already exists one significant amenity here: the pedestrian signal turns in advance of the car signal, giving pedestrians a head start across Rainier S. and making it more difficult for drivers to cut them off in the crosswalk. The Green Feet project has been asked to place pedestrian safety flags here. Feet First would like to see a crossing guard posted in this location.</p>

5. Retain the crossing guard at S. McClellan St.
6. Further examine crossing issues at Rainier Avenue South.
7. Encourage active commuting to change norms. Much of this infrastructure will support walking and biking.
