# LUMMI MACKENZIE/ GOOSEBERRY POINT re+walk

November 15<sup>th</sup>, 2008  
Direct comments to [seth@feetfirst.info](mailto:seth@feetfirst.info)

The re+walk route began at the Lummi CEDAR Project Office and traveled roughly 1.5 miles in a loop down Lummi View Drive and up Mackenzie Road (see map p. 2).

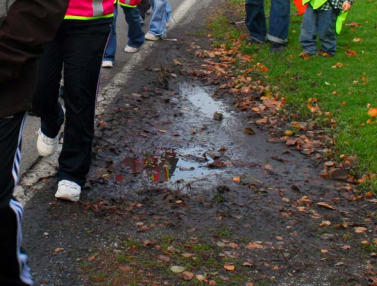
Mackenzie Road	<p>There is minimal space available for pedestrians to walk, and this area is deteriorated. There is often no sidewalk in the Mackenzie/Gooseberry Point, and adequate shoulders are infrequent. Pedestrians are forced into the street.</p> <p><b>Recommendation: Develop an interconnected path network with a paved surface or less intensive material. Until then, work to maintain a clean walking path on the shoulder or side of road potentially through cooperation with local property owners.</b></p>	Pedestrian Path

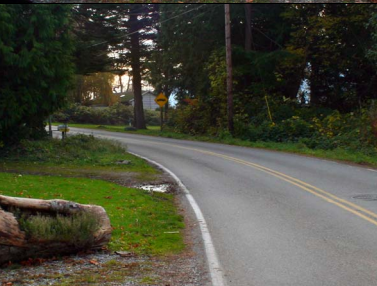
Mackenzie Road	<p>Mackenzie road turns at a point lacking a pedestrian path and with thick vegetation. This limits the site distance and creates dangerous walking conditions.</p> <p><b>Recommendation: Remove vegetation to open up sightlines and give pedestrians and cyclists appropriate safe space outside of the lane.</b></p>	Sightline

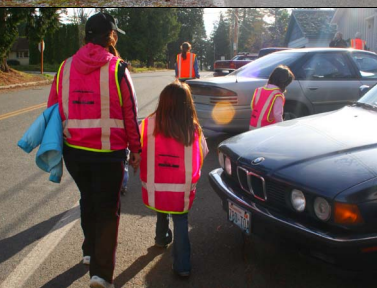
Mackenzie Road	<p>Vehicles use the shoulder along Mackenzie (and other roads) as a parking space. This behavior reduces the space for pedestrians to walk and forces them into the roadway, effectively eliminating the shoulder and putting pedestrians in an unsafe walking condition.</p>	Pedestrian Path

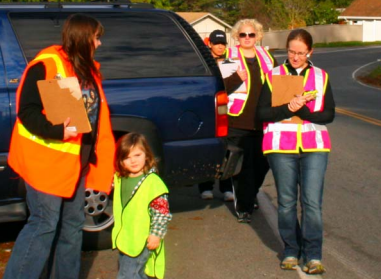
Mackenzie Road	Larger vehicles parked along shoulder block the sightline of all users of the road. <b>Recommendation: Education of this problem, or regulation against it, could improve the safety of all users.</b>	Sightline

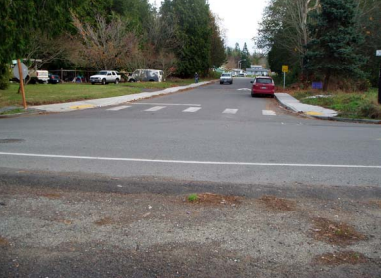
Eagle Avenue and Mackenzie	Eagle Avenue has nice sidewalks on both sides and a crosswalk across Eagle at Mackenzie. Unfortunately, none of these paths continue anywhere, and there is not a crosswalk across Mackenzie to connect to the wider shoulder on the south side of Mackenzie. <b>Recommendation: Extend these existing sidewalks onto Mackenzie Road to create a well needed path network.</b>	Sidewalks

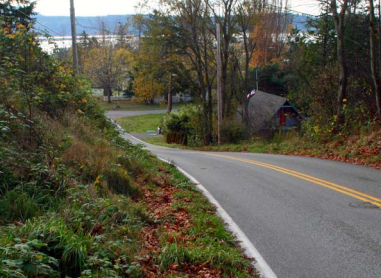
Finkbonner Road and Mackenzie Road	The hill on Finkbonner has minimal space off the roadway for pedestrians to use. The road channel is cut against the bank of the hill. This road creates an important connection between residential areas and the waterfront. Additionally, runners and athletes often like using the hill – the steepest in the area – to train.	Pedestrian Path

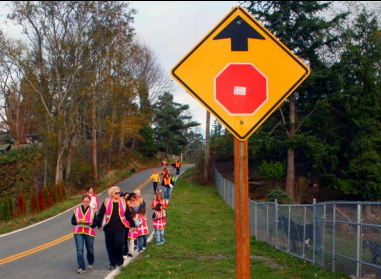
Finkbonner Road and Mackenzie Road	The steep hill on Finkbonner up to the intersection with Mackenzie has poor sightlines. This creates blind turns for vehicles, potentially at the risk of pedestrians and cyclists. <b>Recommendation: Install traffic calming elements (e.g. curb bulbs, texturized paving, raised or marked crosswalks, etc.) and pedestrian scale lighting.</b>	Sightline

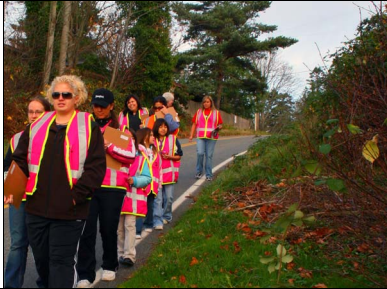
Finkbonner Road	<p>Overgrown vegetation encroaches on the space for pedestrians to walk. There are patches of overgrowth throughout the area. The patch of blackberries along Finkbonner adds to the sightline and lack of shoulder problems with the hill.</p> <p><b>Recommendation: Remove vegetation and potentially landscape hill to provide space for pedestrian path.</b></p>	Pedestrian Path

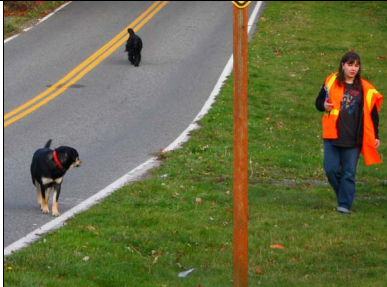
Finkbonner Road	<p>The area is home to many dogs that are free to wander and explore. Though most of the dogs encountered during the walk were friendly, participants expressed that some dogs are aggressive or frightening. Feeling frightened by a dog can create a barrier to a person's desire to walk.</p> <p><b>Recommendation: Work with appropriate agencies (Humane Society, Police, community organizations etc.) to educate dog owners and discourage wandering dogs.</b></p>	Pedestrian Experience

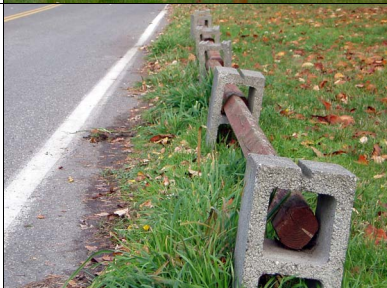
Finkbonner Road	<p>Some residents are placing fences in areas that impede on the shoulder. This becomes a barrier to the pedestrian environment.</p>	Right of Way

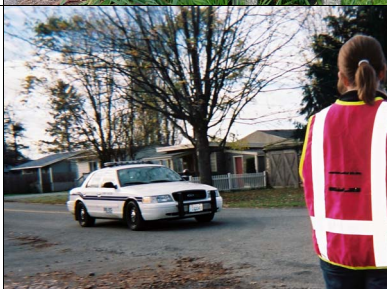
Finkbonner Road	<p>We spoke with the police about enforcement of traffic violations (e.g. speeding, illegal parking, etc.) during the walk. The police informed the group that there is little time or resources to enforce traffic violations. In the past the Lummi Tribe/Bureau of Indian Affairs has requested further funding for traffic enforcement from the Washington Traffic Safety Commission.</p> <p><b>Recommendation: This effort to acquire additional funding for traffic enforcement should continue and could help greatly in creating a better pedestrian environment and encourage people to use the streets.</b></p>	Enforcement

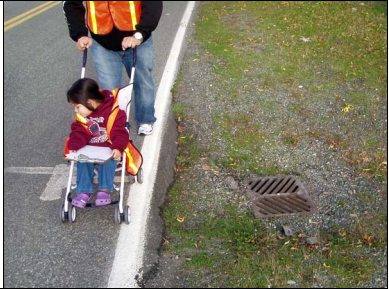
Item	Location	Description	Category	Photo
⌘	Finkbonner Road	One participant of the walk had a stroller demonstrating many barriers in the pedestrian infrastructure. The lack of adequate paths or paved shoulders meant the stroller was repeatedly pushed in the roadway. Additionally the deteriorated street edge often would push the stroller further into the road.	Pedestrian Path

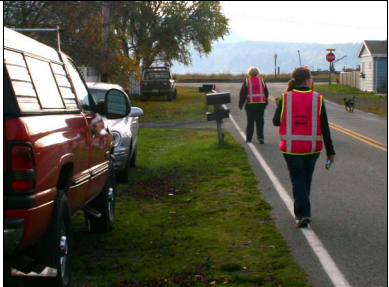
⌘	Finkbonner Road	Pedestrians are given a space in a shallow drainage ditch between parked cars and mailboxes to walk at this point on Finkbonner Road. Located between moving vehicles and parked vehicles, with obstacles like mailboxes periodically in the path, deters many pedestrians from even walking on the shoulder. Instead, they chose a straight path in the roadway, though more exposed to traffic. <b>Recommendation: The pedestrian path should be demarcated as a safe and dedicated path (e.g. gravel, stone pavers, lined with plantings, etc.).</b>	Pedestrian Path

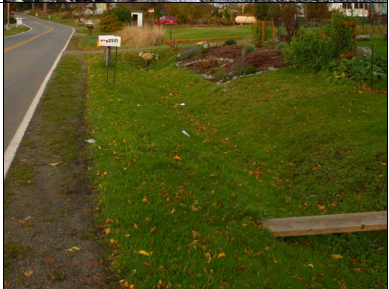
⌘	Lummi View Drive	Drainage ditches at times are creating barriers to destinations, and reducing the space available for pedestrians. Though there are issues with digging near roadways because of buried artifacts, consideration should be given to less invasive pathways (e.g. pavers, boardwalks, asphalt, etc.) and ditches (e.g. bio swales, retention pools, etc.).	Pedestrian Path

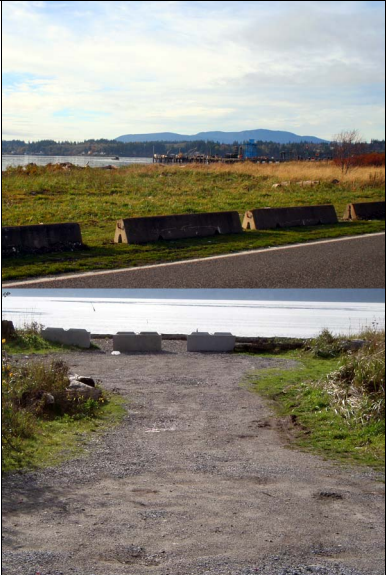
Lummi View Drive	<p>The view and beach along Lummi View Drive is a strong asset and important resource to the Gooseberry Point area and the Lummi Nation. Currently there is no easily accessible or safe way to access the view and the beach, especially as a cyclist or pedestrian. Currently, non-tribal members are not allowed to venture onto the tidelands below the mean high-water mark.</p> <p><b>Recommendation: Provide better signage about accessing the beach. The Lummi Nation should develop a path to attract tribal members, neighbors, and visitors to utilize the beach. The path could contain designated public access areas with proper park amenities (e.g. benches, picnic tables, pedestrian scale lighting, etc) to create a more attractive space with opportunities to recreate, be mindful, and relax.</b></p>	Local Assets

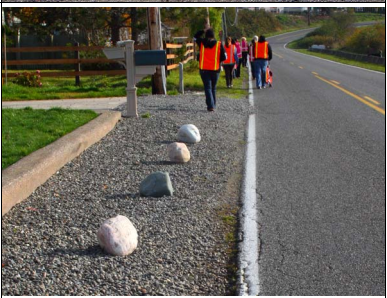
Lummi View Drive	<p>There appears to be contention about property lines and right of way along Lummi View Drive. Some property owners have placed large rocks in the shoulder, partially to deter vehicles from parking there. This also blocks the pedestrian path.</p> <p><b>Recommendation: Government and neighbors should work to reach an understanding about the right of way and appropriate uses. This could be an appropriate place for a pedestrian path (which would also deter vehicles from parking on this side of the road) and be easily integrated into other path networks. However this would put Lummi View and potentially parked cars between pedestrians and the view and beach.</b></p>	Right of Way

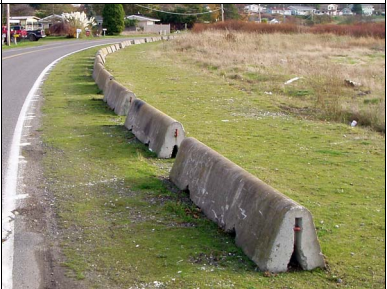
Lummi View Drive	<p>On the south side of Lummi View Drive, there are large cement barriers that block access to the beach, and disrupt a continuous pedestrian path. Participants informed us that these barriers are to make additional ferry parking, and move with the seasons.</p> <p><b>Recommendation: Coordinate better the needs of the ferry with local needs. This side of Lummi View could also be a scenic path. It would be less integrated into the pedestrian network, yet more attractive to users with the road and parked cars behind.</b></p>	Pedestrian Path

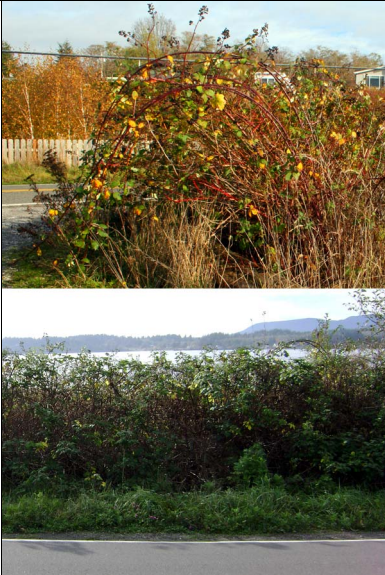
Lummi View Drive	<p>Throughout the Mackenzie/Gooseberry Point, overgrown vegetation (primarily invasive Himalayan Blackberry) crowds the pedestrian path, sightlines, and public space.</p> <p><b>Recommendation: Perform targeted removal to increase the space for pedestrians and improve sightlines. This could be done through community led removal parties to also build neighborhood connections.</b></p>	Right of Way

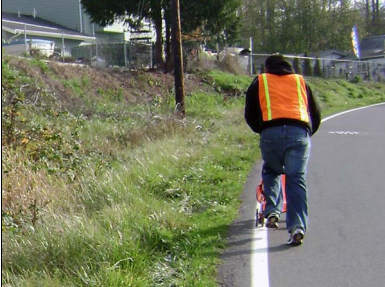
Lummi View Drive	<p>Climbing the hill on Lummi View Drive, there is inadequate shoulder, partially because of overgrown vegetation. This pushes pedestrians, especially those with strollers, into the street.</p>	Pedestrian Path

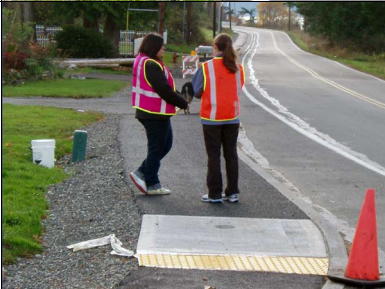
Lummi View Drive	<p>There is a new sidewalk at Lummi Drive and Mackenzie leading towards the K-12 school. This is an important piece of infrastructure creating a needed connection with the school. It would be beneficial to connect the path to the bus stop across the street, or deeper into the Mackenzie/Gooseberry Point.</p> <p><b>Recommendation: Continue to develop pedestrian path and sidewalk segments that connect to the school and connect with each other.</b></p>	Sidewalk

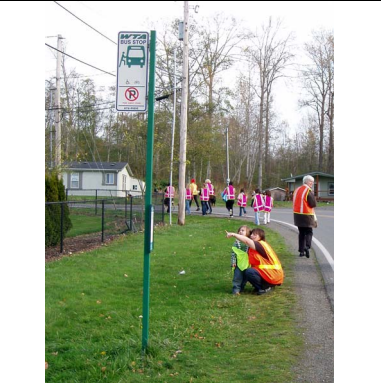
Lummi View Drive and Mackenzie	<p>The Mackenzie/Gooseberry Point is served by local transit. There are several stops (Haxton and MacKenzie, the ferry terminal on Lummi View Drive, and Lummi View Drive and Mackenzie), however none of these have pedestrian amenities or paths near them.</p> <p><b>Recommendation:</b> <i>There should be paths that connect these bus stops to the community to help encourage bus use and build pedestrian routes. Additionally, amenities such as shelters or benches could make them a more pleasant space for bus riders and people walking by.</i></p>	Bus Stop

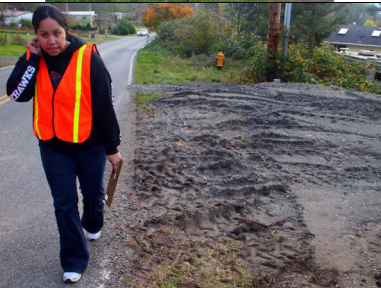
Mackenzie Road	<p>Driveways, such as this one along Mackenzie Road, sometimes disrupt the shoulder or the available pedestrian path. Pedestrians are forced to meander out into the street. Without developing more permanent or intensive paths (e.g. concrete sidewalks), developments and property owners could work to maintain a clean, dry, and smooth path across their driveway.</p>	Pedestrian Path

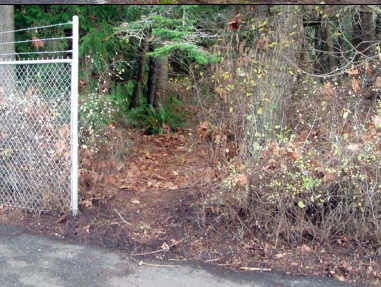
Mackenzie Road and Finkbonner Road	<p>There is an unmaintained trail that connects residences behind the fire station to Finkbonner Road via the Fire Station parking lot. Residents expressed this as an important and well used path, though it is dark, unmaintained, and connected to the poor intersection of Finkbonner and Mackenzie.</p>	Pedestrian Paths

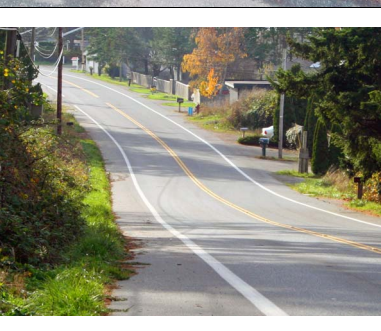
Haxton Way	<p>Haxton Way has a wide and straight clear zone for vehicles. This includes only a paved shoulder for pedestrians and cyclists. Though the speed drops from 50 mph to 35 mph to 25 mph as you enter the Mackenzie/Gooseberry Point, the road's characteristics do not change. There are no indications you are entering a residential area. Participants noted that the ferry at the southern end of Haxton attracts many hurried drivers who wish to quickly move through the area and catch a ferry.</p> <p><b>Recommendation:</b> <i>Change the streetscape to communicate the entrance into a residential area, include traffic calming elements (e.g. street trees, chicanes, bike sharrows, etc), add pedestrian scale lighting, increase enforcement of speeders, and install signage such as 'your speed is' signs.</i></p>	Roadway Design

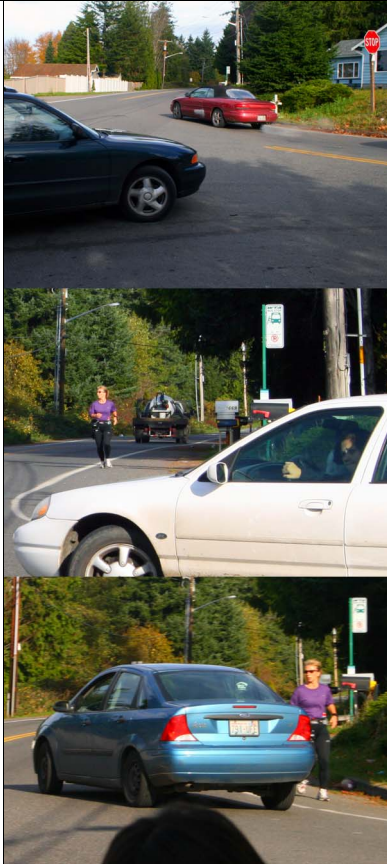
Haxton Way and Mackenzie Road	<p>The intersection of Haxton Way and Mackenzie Road is a wide and relatively unmarked intersection. There are problems with the road channel and with the additional design elements.</p> <p>Regarding the road channel, the turning radii of Mackenzie Road onto Haxton Way encourages drivers to not slow down or stop if making a right turn onto Haxton. During the walking audit, we witnessed a near pedestrian collision with the driver of the vehicle looking left for oncoming traffic and failing to look right, causing them to fail to yield to a pedestrian.</p> <p>Regarding additional details, there are no stop lines and minimal signage suggesting other users of the road. Pedestrians walking along Haxton Way's shoulder are expected to cross Mackenzie without a cross walk, lighting, or cars even coming to complete stops.</p> <p><b>Recommendation: This is an important intersection for all modes of transportation and needs to become a complete street. To remedy these problems this intersection could be reconstructed with a roundabout, or so that Mackenzie approaches Haxton at a right angle with potentially a three-way stop. This could eliminate driver confusion, encourage better awareness of pedestrians and cyclists, and slow traffic speed overall on Haxton Way. Additionally, the roundabout or intersection should provide adequate crossings for pedestrians and cyclists, stop lines, and other traffic calming efforts (e.g. curb bulbs, intersection painting, raised crosswalk, textured pavement, street trees, etc.).</b></p>	Roadway Design/ Driver Education
