## Meadow Ridge Elementary Walking Audit

# Meadow Ridge Elementary Walking Audit

# Meadow Ridge Elementary Walking Audit Field Notes

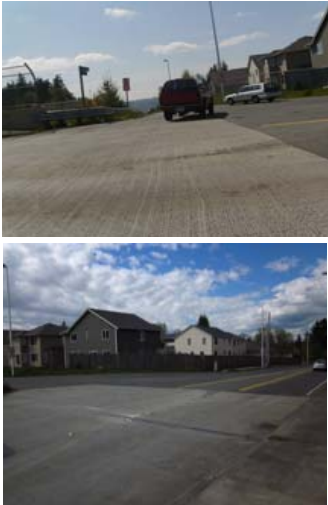
Field Observation Pt.	Intersection	Community Asset	Engineering	Enforcement	Education	Encouragement	Policy	Field Observations	Recommendation	Image
5	108th Ave SE & on ramp to 274th		x					<p>The on-ramp to 274th is a busy intersection. South bound traffic turning right onto the on-ramp travel at high speeds and do not slow down to take the right hand turn.</p> <p>Due to the position of this lane at the top of a hill, sight lines are limited for north bound traffic turning left onto the on-ramp. Drivers can often not see approaching cars.</p>	<p>The city is working to address the many concerns of this location, possible solutions include:</p> <ul style="list-style-type: none"> <li>-Extend the corner curb and reduce the turning radius for cars turning right from 108th Ave SE onto 274th Way.</li> <li>-Work with city officials to determine the appropriate location for a crosswalk. The crosswalk must be well marked. Ideally there would be not only advance warning signs in both directions for drivers, but also an overhead lighting system that will alert drivers from further away.</li> </ul>

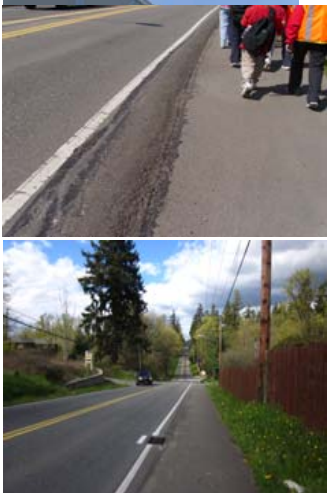
6	108th Ave SE (E side of street from bridge to 272nd)		x					<p>The sidewalk on 108th Ave SE turns into a paved shoulder immediately after the bridge. The area between the pedestrian and the vehicle traffic narrows compromising pedestrian safety.</p>	<p>Work with city and traffic engineers to install both physical and visual barriers which would delineate a more safe walking area for pedestrians. Short term solutions include the addition of turtles and other reflective cones along the edge of the paved shoulder. Long term solutions will be to install a raised sidewalk with planting strip thus separating pedestrians and traffic by at least 3 feet.</p>

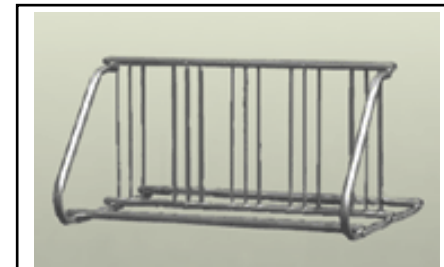
*“Wheel-bender” racks (above) can damage wheels and don’t allow frames to be locked to the rack.*

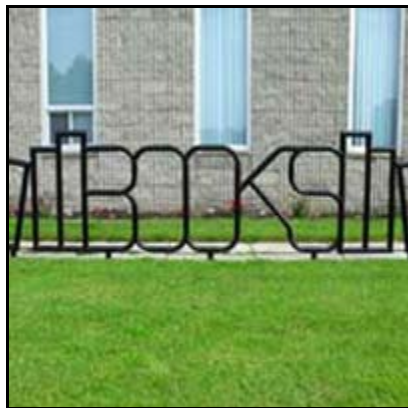
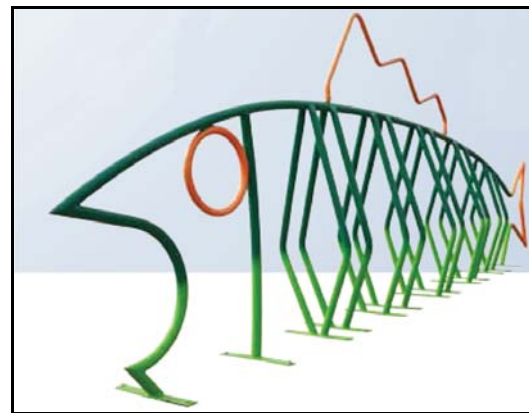
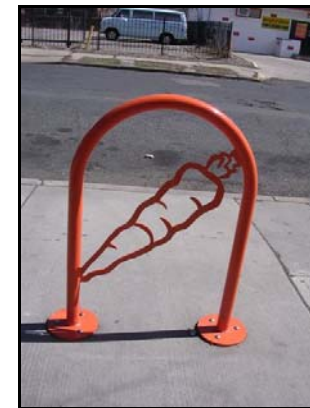
**Customized Designs:** As long as they meet the guidelines discussed above, bicycle racks can serve a dual purpose by promoting a school’s name, mascot, or values (see below).
