Thorndyke Elementary Walking Audit

Thorndyke Elementary Walk Route

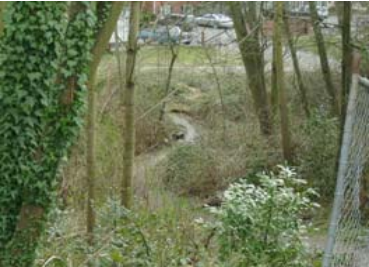
Field Observation Pt.	Intersection	Community Asset	Engineering	Enforcement	Education	Encouragement	Policy	Field Observations	Recommendation	Image
1	Trail to apartments	X			X			<p>This trail behind the school connects to the apartment complex along Southcenter Blvd. The City has worked to keep this trail open for pedestrians. It is well used by students and community members even though in parts it is slippery, and steep. In winter months it is not well lit. The trail needs some maintenance to clean up the overgrown blackberries and clear out the trash.</p> <p>Participants did not express concerns about crime in this area, nor a fear of having children use the path. However there is no pedestrian infrastructure in the apartment parking area. There are no crosswalks for pedestrians and cars are not warned that people may be crossing from the trail through the parking lot to the apartments.</p>	<p>Keep this trail open and accessible to students. The school can organize a trash pick-up day to involve students in the improvement of this area. Work with the apartment management to install painted crossing locations for students and other pedestrians to use as well as install a sign for motorists warning them of pedestrian crossing.</p>

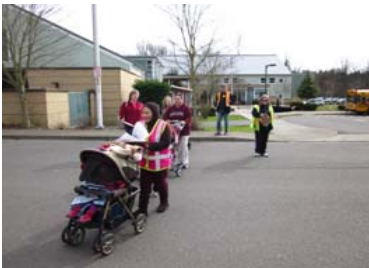
2 Top Recommendation #1	150th and Thorndyke Elementary		X					<p>There are currently no marked crosswalks on S 150th St. between 42nd Ave. S and the school campus. Many students cross diagonally from the front of the school to the "Rocky Road" (pedestrian access only on 46th Ave. S.) in order to head toward the Middle school and neighborhoods N/E of the school.</p>	<p>City engineers should work with the school to determine preferred location and place at least one marked crosswalk in this corridor.</p>

1. Work with city engineers to determine and mark the most appropriate crossing location for students to travel across 150th in front of the school. There is no designated crosswalk in front of the school to direct foot traffic across 150th. Many students cross diagonally from the front of the school to the “Rocky Road” in order to head toward the middle school and neighborhoods N/E of the school. Feet First suggests crossing at the location on the east side of the parking area where there is currently an adult crossing guard stationed to help facilitate safe crossing. Since parents often park east of this location during pick up and drop off adding a crosswalk will make this crossing official and support additional changes in pick up and drop off procedures. (Field note 2)

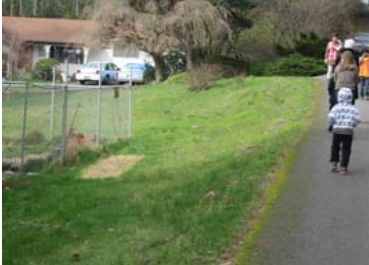
3	150th and 46th							<p>The house on the corner keeps 3 large dogs that bark and charge when people walk past the house on the route to 'Rocky Road'. The dogs are in an enclosed pen, so it is more an issue of comfort than safety at this location.</p>

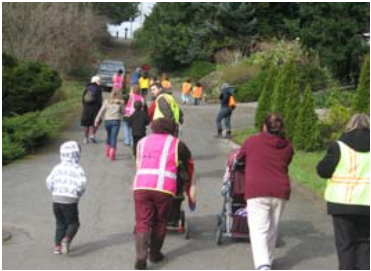
Field Observation Pt.	Intersection	Community Asset					Field Observations	Recommendation	Image
		Engineering	Enforcement	Education	Encouragement	Policy			
4	Rocky Road'	X					<p>The designated trail serves many people in the community. The trail is also rather steep and tends to be slippery due to moss build up on the pavement. Getting to the trail pedestrians use 46th Ave S which is an active street used by neighbors as well as waste and recycling trucks. The common practice of adults and children alike is to walk in the middle of the street.</p>	<p>This is a good location for educators to teach students about recognizing when they are transitioning from one kind of walking environment to another. Mark standard street lines as well as a designated walking area along 46th Ave S to inform pedestrians and drivers alike that this is an active street for cars and peds. Work with city trail/parks and recreation departments to power wash the asphalt and remove moss or coordinate a community effort to mobilize volunteer labor.</p>

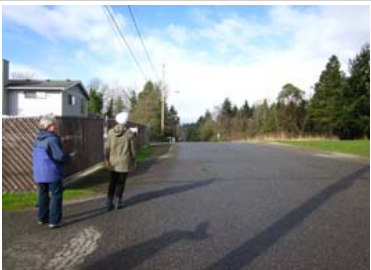
5	Rocky Road and S. 149th St			x			<p>The 'pedestrian only area' of Rocky Road ends at the top of a hill. There is poor pedestrian visibility as when crossing because of a downward hill to the west.</p>	<p>This is a good location for educators to teach students about sightlines and the importance of listening for traffic as well as looking for it.</p>

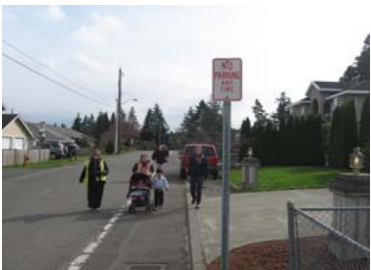
6	Top Recommendation # 2 46th Ave. S between S. 148th St. and S. 144th St.	x				x	<p>There are few pedestrian facilities along 46th Ave. S. The designated walking area, marked by a paved shoulder (painted right of way line), is on the west side of the street. Cars parked in the ROW are problematic for pedestrians who have to walk into the flow of traffic in order to get around the car. Additionally, trash/recycle bins are routinely placed in the sidewalk and paved shoulders creating obstacles for pedestrians.</p>	<p>Inform residents who live along this street of dangers that parking in the ROW creates for pedestrians. Work with the City of Tukwila and private garbage/recycling companies place empty bins out of the way of pedestrian paths. Additionally, work with local residents and encourage them to place trash/recycle containers out of the way of pedestrian paths. There have been successful sticker campaigns that work with all parties to get bins out of the pedestrian walking area.</p>

2. In order to support the policy of paved shoulders the city can work with the community to create an education campaign to inform drivers of the impacts of driving patterns on pedestrian safety. Using City of Tukwila, community and school support an education and outreach campaign can target homeowners as well as local businesses informing them of the correct use of paved shoulders and driveways. (Field note 6 &16)

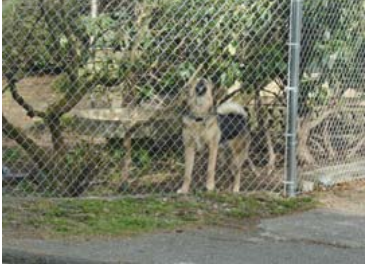
Field Observation Pt.	Intersection	Community Asset	Engineering	Enforcement	Education	Encouragement	Policy	Field Observations	Recommendation	Image
	7 S. 146th St. and 46th Ave. S			x				Participants comment that many cars run this 4 way stop.	Police enforcement of this area could help improve pedestrian safety.	
7	46th Ave. S between 146th and 144th.				x			Students counted more than 8 noisy dogs on this block. All dogs were contained, but barked at and approached the group as we passed. For some, this created discomfort, while for others it was entertaining and interesting.	Education tools like scavenger hunts can be a fun way for children and adults to realize how much more they can see and notice when on foot compared to when in a car.

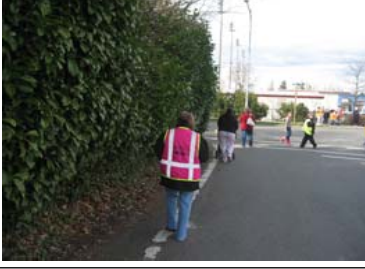
8	46th Ave. S and S. 144th St.		x		x			Overgrown bushes on the west side of the street block use of the paved shoulder walking area, and impede pedestrian visibility to drivers on busy 144th St.	The overgrowth needs to be cut back. There needs to be a crosswalk sign or a better marked crosswalk. Request maintenance from home or property owner to help improve pedestrian visibility. Private property issues that affect public rights-of-way can be referred to Tukwila City Code Enforcement at (206) 431-3671.

8	46th Ave S. at 144th St.				x			Pedestrians need to cross 46th from the paved shoulder before reaching the designated crosswalk across 144th. While this seems inconvenient at first, sightline issues at the corner make it clear that the painted locations were chosen for safety reasons. Traveling south from this location, however, could be problematic for pedestrians to use the paved shoulder on 46th Ave S.	Indicate this intersection as a preferred crossing point for the school walk route map to cross 144th Street on the east side of the intersection where the crosswalk is currently painted. Feet First should work with the City to determine appropriate walk route recommendations for traveling south on 46th Ave. S. and simliar locations in the area.

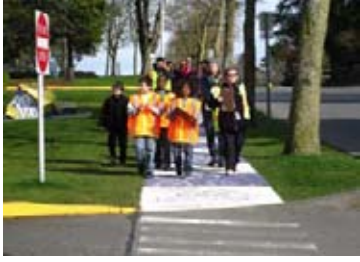
Field Observation Pt.	Intersection	Community Asset	Engineering	Enforcement	Education	Encouragement	Policy	Field Observations	Recommendation	Image
	Sidewalk in front of Foster 9 High school	x						The painted sidewalk in front of Foster High School adds to community character and visibly marks the area as a school zone. The planting strip with large trees adds to the pedestrian comfort and appeal, even on this busy street.

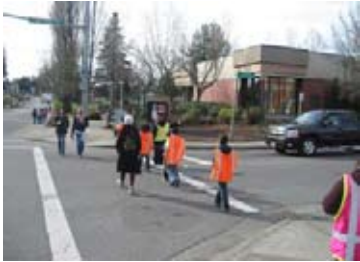
10	144th and 42nd		X	X				The intersection of 144th St. and 42nd Ave S. becomes congested during the morning and afternoon school dismissal times due to the volume of students crossing the street. This intersection is a four way stop and does not have a signal to assist students in crossing the street.	City engineers should work with the school to determine if this is an appropriate intersection for a stop light with a pedestrian crossing signal.

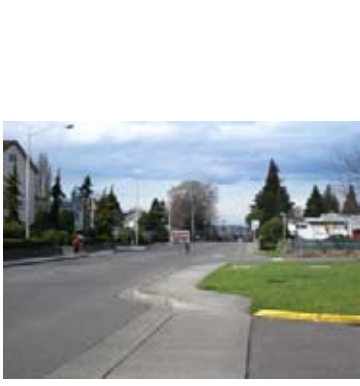
11 Top Recommendation #3	42nd, north of 144th: midblock crossing							Participants asked to take a detour from our designated route to witness a common problem especially for students pedestrians in this area. Students living in the housing complex to the west will cross here in the morning, either to go directly to the high school or to catch the bus to Thorndyke. (In the afternoon, they do this in reverse). This results in a high number of students crossing midblock with no designated path or assistance. There are no marked crossings on this stretch of road, although there are pedestrian generators on each side.	City engineers should work with the school to determine preferred location and place at least one marked crosswalk in this corridor, possibly at this location.

3. There is a long stretch north of 144th without a designated crossing spot and there are significant pedestrian generators (the housing complex on the west and the middle/high school on the east side)A marked crossing is necessary north of 144th to accommodate Thorndyke students who travel from the housing on the west side of the street to the school bus pickup behind Showalter Middle School. (Field note 11)

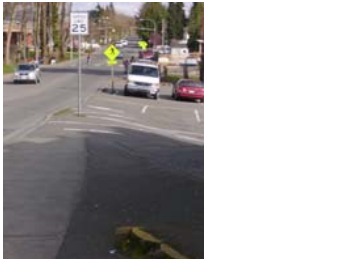
12	144th and SR 99							This is a very busy intersection. High school students want to get to the Jack in the Box across SR 99.

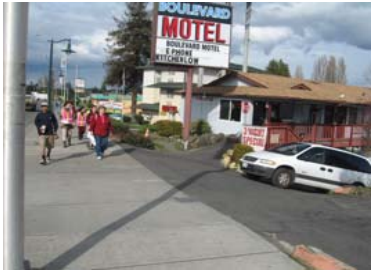
Field Observation Pt.	Intersection	Community Asset	Engineering	Enforcement	Education	Encouragement	Policy	Field Observations	Recommendation	Image
13	Along SR 99			X			X	Drug deals, prostitution, and police activity have been witnessed. Hwy 99 is very busy major street with fast moving traffic. There are smoke shops, pawn shops, and cars entering and exiting from steep driveways. There's a steep driveway along the Eastside of SR 99 where it may be difficult for a driver to look for traffic and pedestrians.	Work with area police to conduct targeting speed enforcement at this location. The school can provide parents/guardians with appropriate phone numbers to report illegal activity.

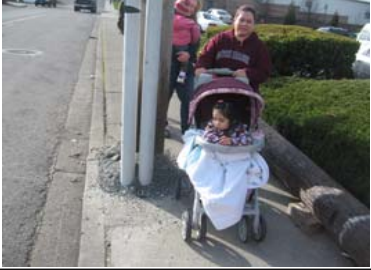
14	Along 146th, between 42nd and SR 99		X					A new power pole is in the middle of the sidewalk on the north side of S. 148th sty.

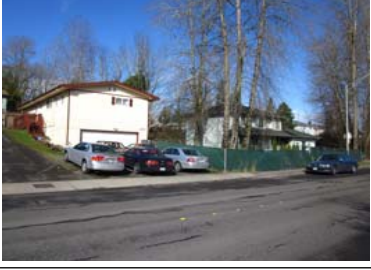
15	146th and 42nd		X	X				A tall wooden fence blocks visibility at the corner. Cars parked in driveways block sidewalk.	Inform residents who live along this street of dangers that parking in the ROW creates for pedestrians.

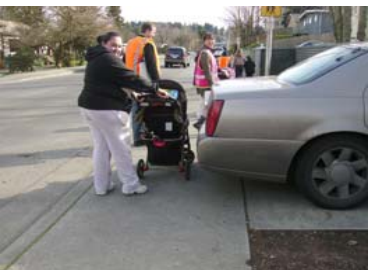
16 Top Recommendation # 2	148th and 42nd		X					There are lots of driveways and people pulling in and out. There are overgrown bushes on the north side. The slanted driveways and sidewalks make it difficult for people with strollers and wheelchairs.	Request maintenance from property owner to increase visibility and inform them of the dangers that parking in the ROW creates for pedestrians. Education for children should emphasize the importance of awareness of driveway issues, both on foot and by bike

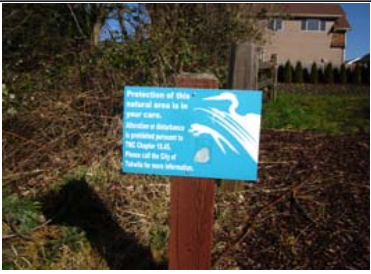
Field Observation Pt.	Intersection	Community Asset	Engineering	Enforcement	Education	Encouragement	Policy	Field Observations	Recommendation	Image
17	150th heading East toward school	x						Creek and stream are great community assets however it often gets overgrown. One participant mentioned that she has personally cut back vegetation in order to clear the sidewalk.	Work with city to maintain clear sidewalks. School can organize work days with community to clear the vegetation and public information signs.

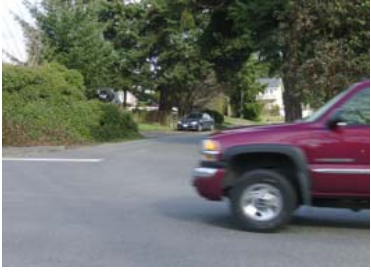
18	152nd, near 42nd		X					This is another location off the scheduled loop. Two participants pushing strollers asked us to look specially at this location because it causes difficulty for them on their walks to school. There are no sidewalks on 152nd, posing a particular challenge for pedestrians with strollers as the walk the steep hill to or from 42nd. Wide curb radii at the intersection result in fast moving traffic making this turn. Participants emphasize that it does not feel safe to walk here.	City engineers should work to improve the pedestrian safety and infrastructure in this area.

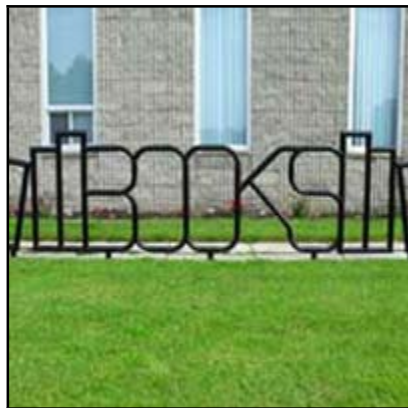
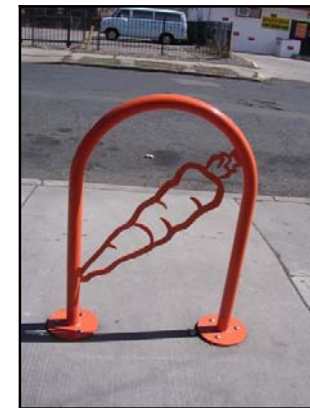
Customized Designs: As long as they meet the guidelines discussed above, bicycle racks can serve a dual purpose by promoting a school’s name, mascot, or values (see below).
