Tukwila Elementary Walking Audit

King County Public Health

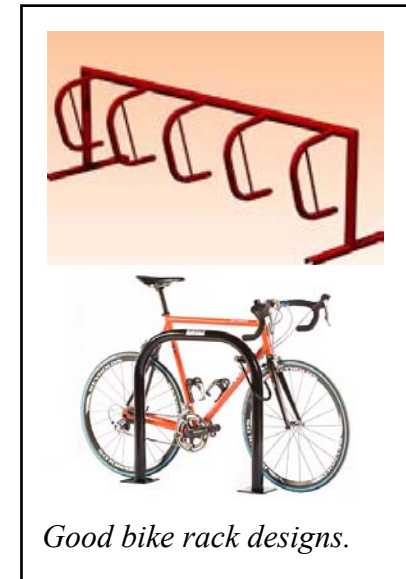
Theft is a serious concern for bicyclists. Nearly 1.5 million bikes are stolen in the U.S. each year. Safe and convenient parking is as critical to bicyclists as it is for motorists. Racks should:

- Be placed in areas with high pedestrian activity and “eyes-on-the-street”
- Be more visible to staff and students than passersby
- Allow the frame and one wheel to be locked to the rack when both wheels are left on the bike
- Allow the frame and both wheels to be locked to the rack if the front wheel is removed
- Allow the use of either a cable or U-shaped lock
- Be securely anchored.

In areas with high crime concerns, schools should consider placing racks in rooms or cages that can be locked during the school day.

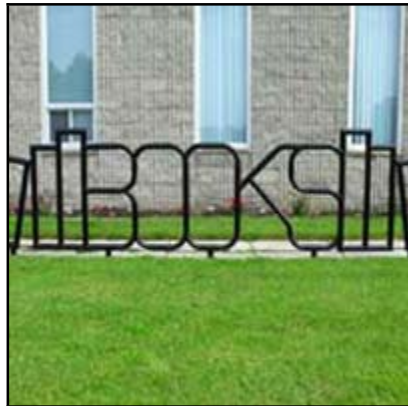
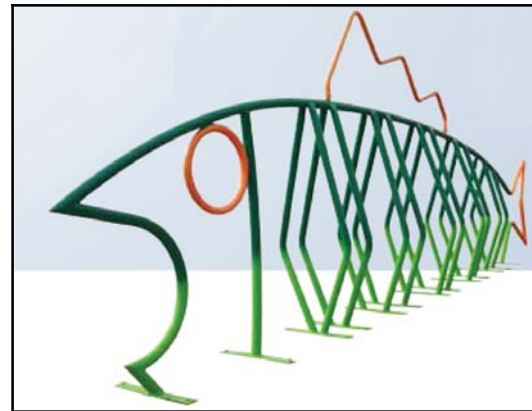
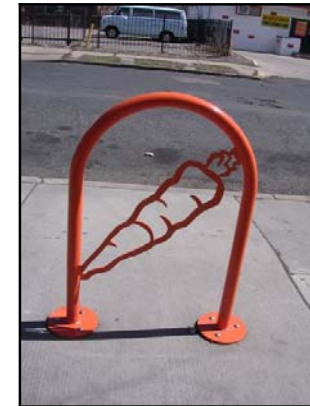
Customized Designs: As long as they meet the guidelines discussed above, bicycle racks can serve a dual purpose by promoting a school’s name, mascot, or values (see below).
