White Center Heights Elementary Walking Audit

Audit Date:
December 8, 2010

Issues and Action Items for SE Route - White Center Heights community

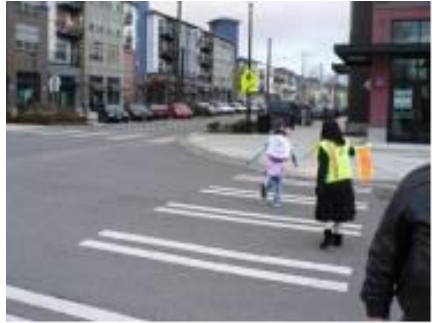
Item	Location	Description	Photo
1	Crosswalk on the east side of 8th Avenue SW crossing SW 100th Street Top Recommendation #2	<p>A crossing guard staffs this marked crosswalk near the school after school, when this intersection gets crowded with family vehicles. The guard reports poor driving behavior and illegal parking on and near the marked crosswalk, restricting movement and visibility for pedestrians.</p> <p>Feet First recommends that a second guard be placed at this corner because of the high volumes of both pedestrians and traffic.</p>

2. The crossing guard at 8th Avenue and 100th Street needs to be retained and increased to include a second guard.
3. The main school entrance / parking lot area is a difficult environment for pedestrians and holds potential for more difficulty as new housing is completed. WCH should apply for funding from the Washington Traffic Safety Committee to bring a student patrol program for help in the school drop-off / pick-up area.

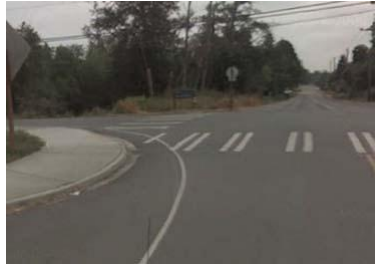
4	Intersection of 8th Avenue SW and SW 102nd Street	Looking south of SW 102nd Street on 8th Avenue SW, the pedestrian and transit infrastructure disappears: there are no sidewalks on either side of 8th Avenue SW south of 102nd, and the bus stop on the south side of 8th Ave lacks shelter and adequate landing. A teacher informs us that on this block around 2 years ago, a student pedestrian was hit by a car when walking to school with siblings. Sidewalks on this street would greatly improve pedestrian safety, and are in great need throughout the area. Feet First recommends that any walking encouragement campaigns on the part of KCFFI require parental supervision for students walking from south of the school.

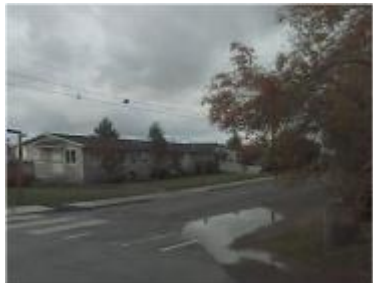
6	Intersection of 6th Avenue SW and SW 102nd Street	Large water puddles consistently appear at the NE corner of this intersection and restrict pedestrian access. The King County DOT engineers, who accompanied us on the walk, offered their engineering services to redirect the water flow with drainage remediation.

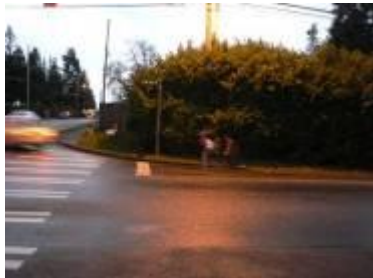
8	South side of SW 102nd Street near intersection with 4th Avenue SW	For drivers, the laurel hedge at the SE corner of the intersection blocks visibility of pedestrians crossing 4th Avenue to the north toward school. For the 3 young teens observed in this photo, the lack of sidewalk and overgrown hedge push them dangerously into the roadway with traffic to their backs. Education is necessary to teach young pedestrians to walk facing traffic when sidewalks are missing. However, the option on the other side of the street is not much better (see item #7). Feet First recommends that maintenance be scheduled to trim this hedge away from the pedestrian right of way.

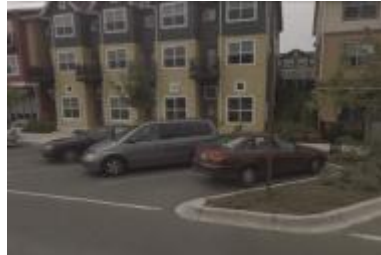
Item	Location	Description	Photo
13	Street parking along 8th Avenue SW between SW 100th Street and SW 97th Street	<p>There is apparent confusion regarding the proper back-in method for the diagonal street parking. When cars pull forward into these spots, it puts them in the position of having to back out across a lane of traffic while exiting. There is an opportunity for education focused on how to perform back angle parking and why it is better for pedestrians, cyclists, and drivers.</p>

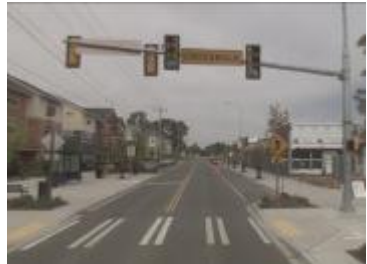
14	Mid-block pedestrian crossing at 8th Avenue SW just south of SW 97th Street	<p>This location is a working example of mixed-use transportation planning: bulb-outs are installed north and south of the mid-block crosswalk that features an overhead traffic signal; bus schedules are posted at the stop near this intersection thanks to the efforts of the Greenbridge Community Action Team. This group's efforts continue as they now request the installation of a public telephone along this stretch of 8th Avenue SW.</p>

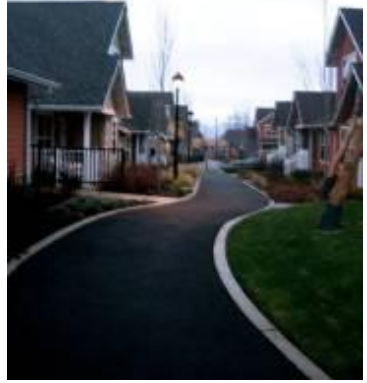
15	Walkway connecting 9th Place SW and 9th Avenue SW	In this area, residents have access to a pedestrian-only walking path that features artistic sculptures. This path provides beneficial neighborhood connectivity and shared walkable greenspaces.

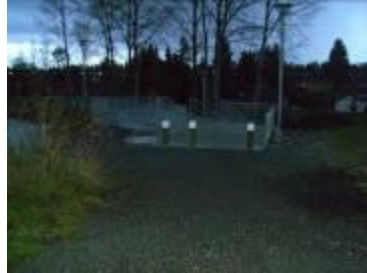
16	Staircase just east of 12th Avenue SW and 98th Street	Currently, SW 97th Street ends for drivers and pedestrians at 10th Avenue SW, leaving a gap in the connection between 10th Avenue SW and 12th Avenue SW. Feet First recommends a gravel path be installed between the communities of White Center and Greenbridge to connect the staircase just east of 12th Avenue SW and SW 98th Street to the corner of 10th Avenue SW and SW 97th Street.

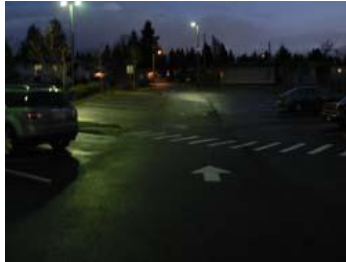
Item	Location	Description	Photo
20	Crosswalk through White Center Heights Elementary parking lot at SW 100th St Top Recommendation #3	Visibility of pedestrians can be blocked by parked vehicles close to the crosswalk in the elementary parking lot. Teachers report that after parent drivers pick-up or drop-off their children at school, they are prone to speed right through this crosswalk. High volumes of personal vehicles before and after school make this area difficult to navigate on foot. The number of pedestrians crossing this area will possibly increase as housing is completed to the northeast of the campus. Feet First recommends that White Center Heights pursue a grant from the Washington Traffic Safety Commission to create a student patrol to help with pedestrian safety in the drop-off and pick-up area
