SOUTH LAKE UNION – TRANSIT ACCESS & RIDERSHIP re+walk – AUGUST 30, 2006

The South Lake Union neighborhood (SLU) in Seattle is an up-and-coming neighborhood. In the past its industrial character precluded the development of much residential or mixed-use development. A recent revival of SLU has incorporated dense residential development, several new companies that draw more people working in the neighborhood, and new shops, restaurants and cafes. **STREETS WALKED:** Westlake Avenue North, Thomas Street, Harrison Street, Dexter Avenue North, Mercer Street, Fairview Avenue North, and John Street.

Aerial Photo of re+walk Route: developing office, retail, residential and industrial areas.

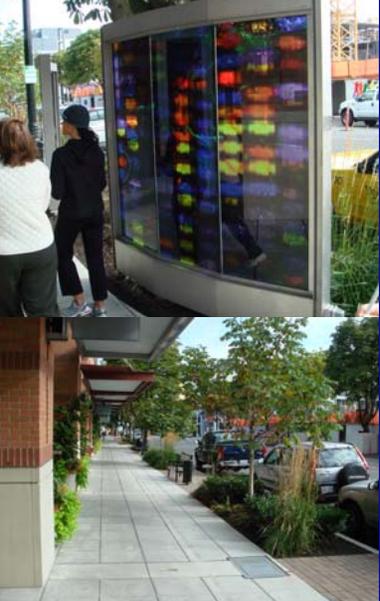
Item	Location	Description	Photo
1 ⌘	Westlake Ave N and Thomas St	Pedestrian environment is greatly enhanced by bench, awnings, brick pavers, new plantings, and screen artwork, as well as windows that interface well with the sidewalk. Tree wells do not intrude into sidewalk space. This is a great example of how new development can enhance the pedestrian environment

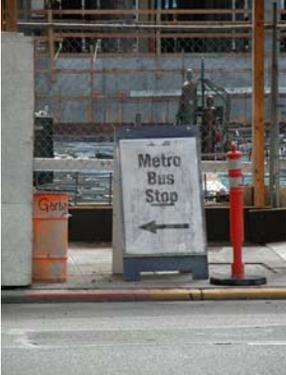
Item	Location	Description	Photo
2

Westlake Ave N	Bus stop (#17) is invisible because of construction activity, even though temporary signage has been placed

1. Visibility of bus stops should be enhanced by using several possible methods: wayfinding, signage, shelter design, placement, collocation with street furniture (such as waste receptacles, bike racks, or newspaper vending boxes)
2. Because construction is a disruption that will likely occur in SLU for quite some time, it is important that bus stop location during construction be clearly marked, and every attempt should be made to keep stops open for the duration of construction.
3. Working with development companies in SLU to engage with them on pedestrian-oriented design near bus shelters and bus stops is high priority for securing an environment that supports a vibrant and walkable South Lake Union.
4. Continued expansion of service will be needed as more people come to work in South Lake Union.
5. Location of bus stops should be placed adjacent to where crosswalks are already placed

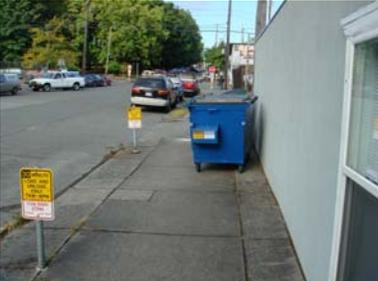
Thomas St and 9th Ave N	Dumpsters on sidewalks, uneven sidewalk, and graffiti erode the pedestrian environment

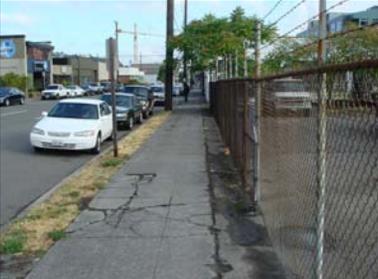
9th Ave N between John St and Thomas St	Chain Link, rusted, with barbed wires creates atmosphere of decay, and deters pedestrian activity. Next door, though, an open garage with workers inside the Iron Works promotes interface with sidewalk and makes the block more inviting and interesting (while giving the neighborhood character)

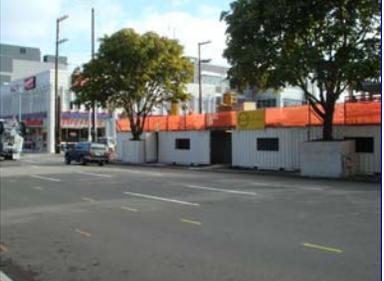
Westlake Ave N	Even though sidewalks may be accessible during construction it may deter people from using the sidewalk

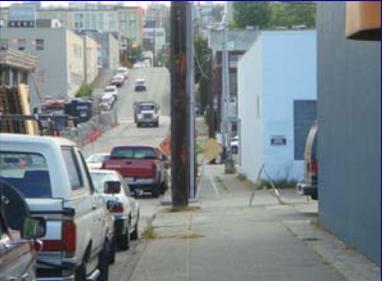
Westlake Ave N and Mercer St	Utilities poles (and construction signs) create competition/unsafe conditions for pedestrians and cyclists at corners

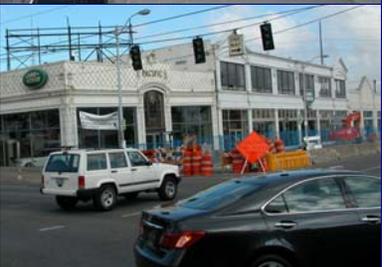
Mercer St	Mercer Street is unwalkable, loud, there are not enough crossings, existing crossings are not well-marked, wayfinding to local workplaces difficult, double left turns into crosswalks on Mercer/Fairview create less safe environment for pedestrians, and construction constricts access to remaining sidewalks; one suggestion for future crosswalks might be to have an on-demand push button for pedestrians (that turns green when pushed)

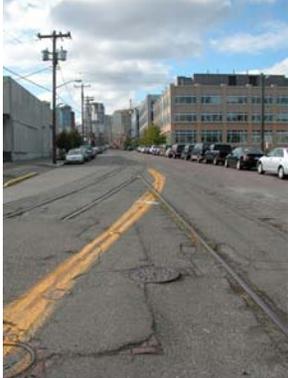
Terry Ave N	Curb ramps are wide and promote good accessibility, though streetcar tracks (post-operational) could be a challenge for wheeled transportation

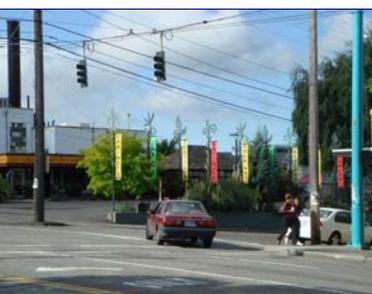
Fairview Ave N, other streets (Harrison St)	Street Trees are an asset to the pedestrian environment, softening the effect that traffic and traffic noise has. Coupled with businesses providing banners, they add interest to the pedestrian environment, may calm traffic, and create a more neighborhood-friendly streetscape

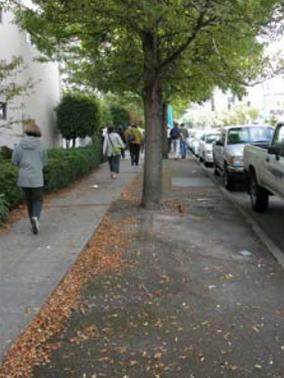
Fairview Ave N	Blacktop between the sidewalk and street is broken and uneven especially around trees; mature trees are a great asset and care should be taken to preserve them as new construction comes to different areas

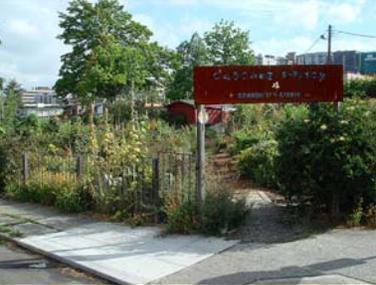
Thomas St and Minor St	The Cascade P-Patch is a wonderful neighborhood resource, providing one of the few green and open spaces along the re+walk route. Depending on interest, more spaces should be looked to in South Lake Union for creating another p-patch, and if there's not interest in another p-patch a pocket park, a plaza space, or any other type of open space should be pursued (or required) as part of future development

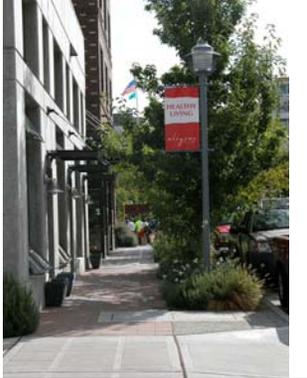
Harrison St, Pontius Ave N	Alcyone and Paddy Coyne’s landscaping (dog art, new sidewalk, plantings, street trees, step-up from sidewalk to outdoor seating area) is a huge benefit to character of neighborhood

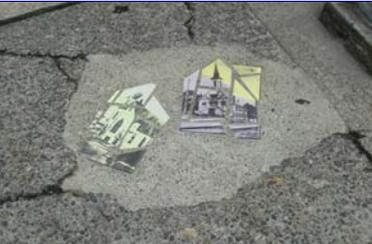
Behind Yale off of John Street	Placemaking activities such as embedded tiles in the concrete add to the neighborhood character

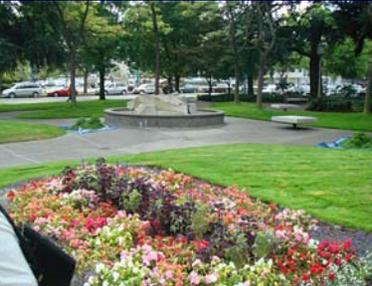
Boren St (new senior living development, Mirabella)	No curb ramps, uneven street and sidewalk causes inaccessibility to the park (shown to the right) one block away. This park is a great open space resource for seniors or anyone else, and attention should be paid to allow for access for people of all abilities

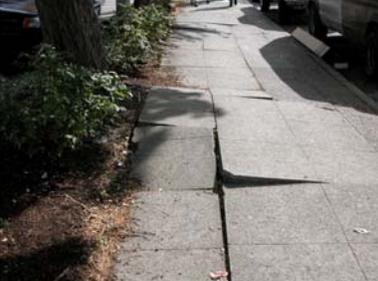
John Street	Uneven pavement needs to be fixed; this would especially affect those who are sight-impaired or in a wheelchair

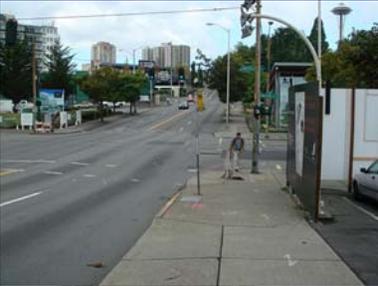
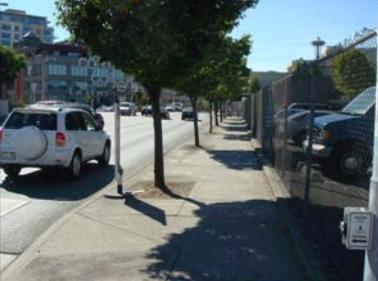
Denny Street	Not comfortable despite wide sidewalks; in this area the sidewalk needs to be even wider because of traffic (amount) and traffic speed. Some sidewalks (such as those shown) are adjacent to parking lots; future development along these routes should take into consideration an enhancement of the bus stop and sidewalk environment. The location of the #8 bus stop near Whole Foods could be reconsidered to allow for a more convenient crossing

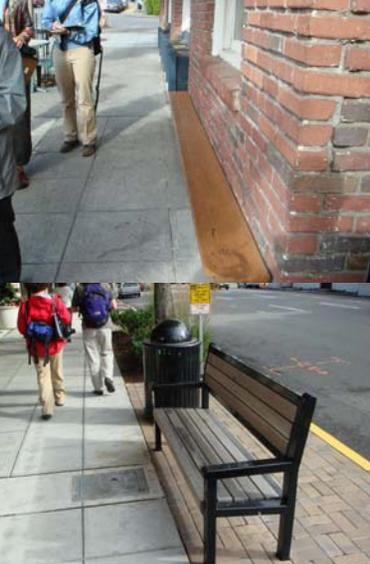
General comment	Benches are a great asset, and could be placed by business/corporation owners adjacent to bus stops to provide more seating. Benches also invite more street activity, leading to a more vibrant neighborhood

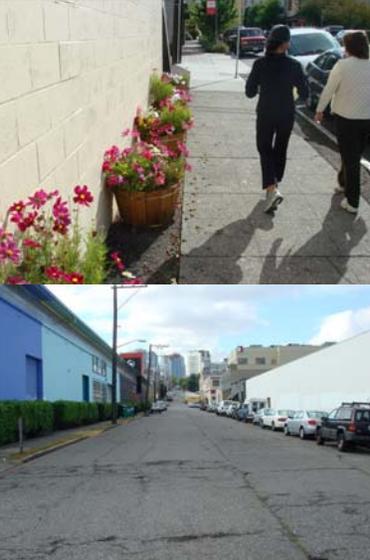
General comment	<p>Blank walls are detrimental to the pedestrian environment. Future development shouldn't include blank walls, and current temporary solutions could include planting boxes or murals.</p> <p>Additionally, many streets have a wide right-of-way for vehicles and narrow sidewalks. These locations should be considered during future development as opportunities for developers, King County Metro (where bus lines exist), the Seattle Department of Transportation and other city agencies to work together in enhancing the pedestrian environment</p>

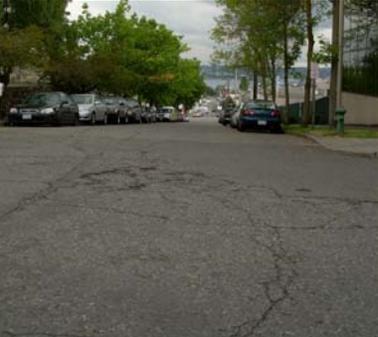
General Comment	Connections to areas West of South Lake Union and to the future Lake Union Park should be considered as well as view connections (the view to Lake Union is shown on the right). The view to the EMP and Seattle Center on Harrison not utilized since east-west connection is not possible (Aurora obstructs the connection). In the more distant future

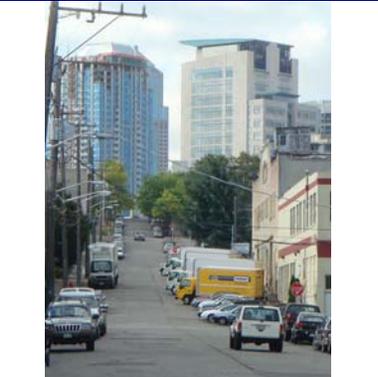
Wayfinding Suggestions	Experimenting with sidewalk paint that indicates bus route and bus route location from non-bus-route streets could be very artful, contributing to wayfinding but also to the unique character of the neighborhood that exists already. More standard wayfinding kiosks including bus info and public spaces should be included in area (similar to kiosks that exist in Downtown Seattle). Wayfinding landmarks include the Steeple of Orthodox Church at Yale Ave N and Harrison, the view to Lake Union, the view to St. Mark's on Capitol Hill, views to the Space Needle, etc. makes a good wayfinding device is the location. There is also a desire to turn "up" streets (to the South) because of downtown buildings and how they can be used in wayfinding as a landmark
