Cascade View Elementary Walking Audit

King County Public Health

Cascade View Walking Audit

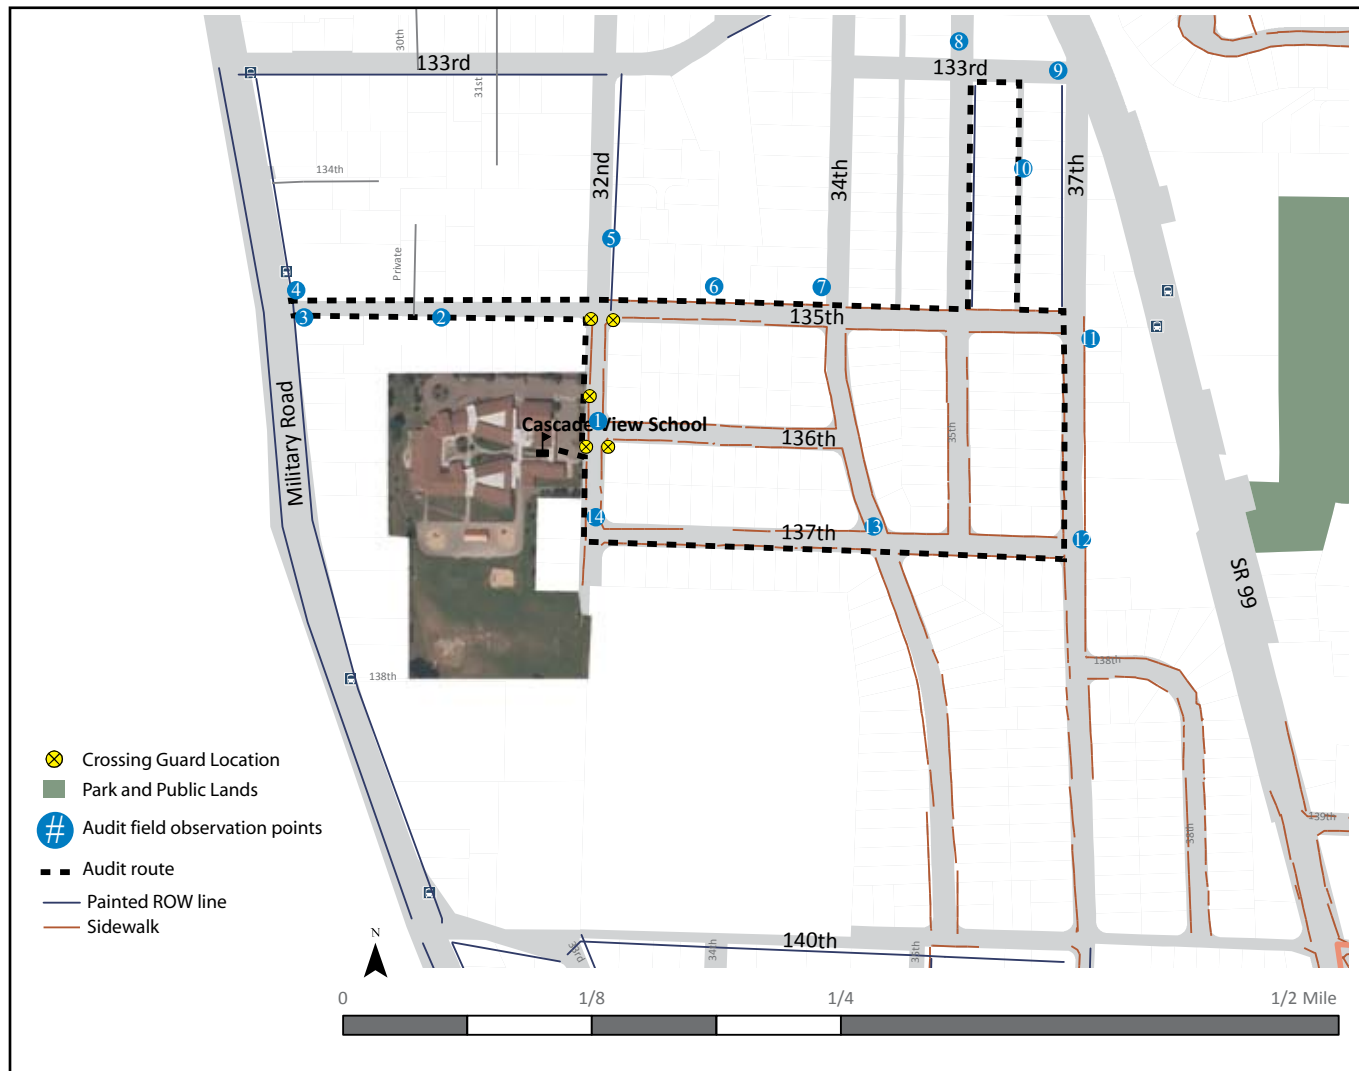
Cascade View Audit Route 1

Route 1 focused on the north and east of the school, specifically examining Military Road, the nearby neighborhood, and the apartment complexes north of 133rd. Route 1 participants began by examining the school grounds. They then preceded north on 32nd and west on 135th to Military Road. After discussion at this point participants returned east along 135th to 35th, where they turned north to examine the apartment complexes north of 133rd. The group noted the alley between 35th and 37th, as well as the walkway along 37th. The group continued south on 37th to 137th, then headed east back to the school.

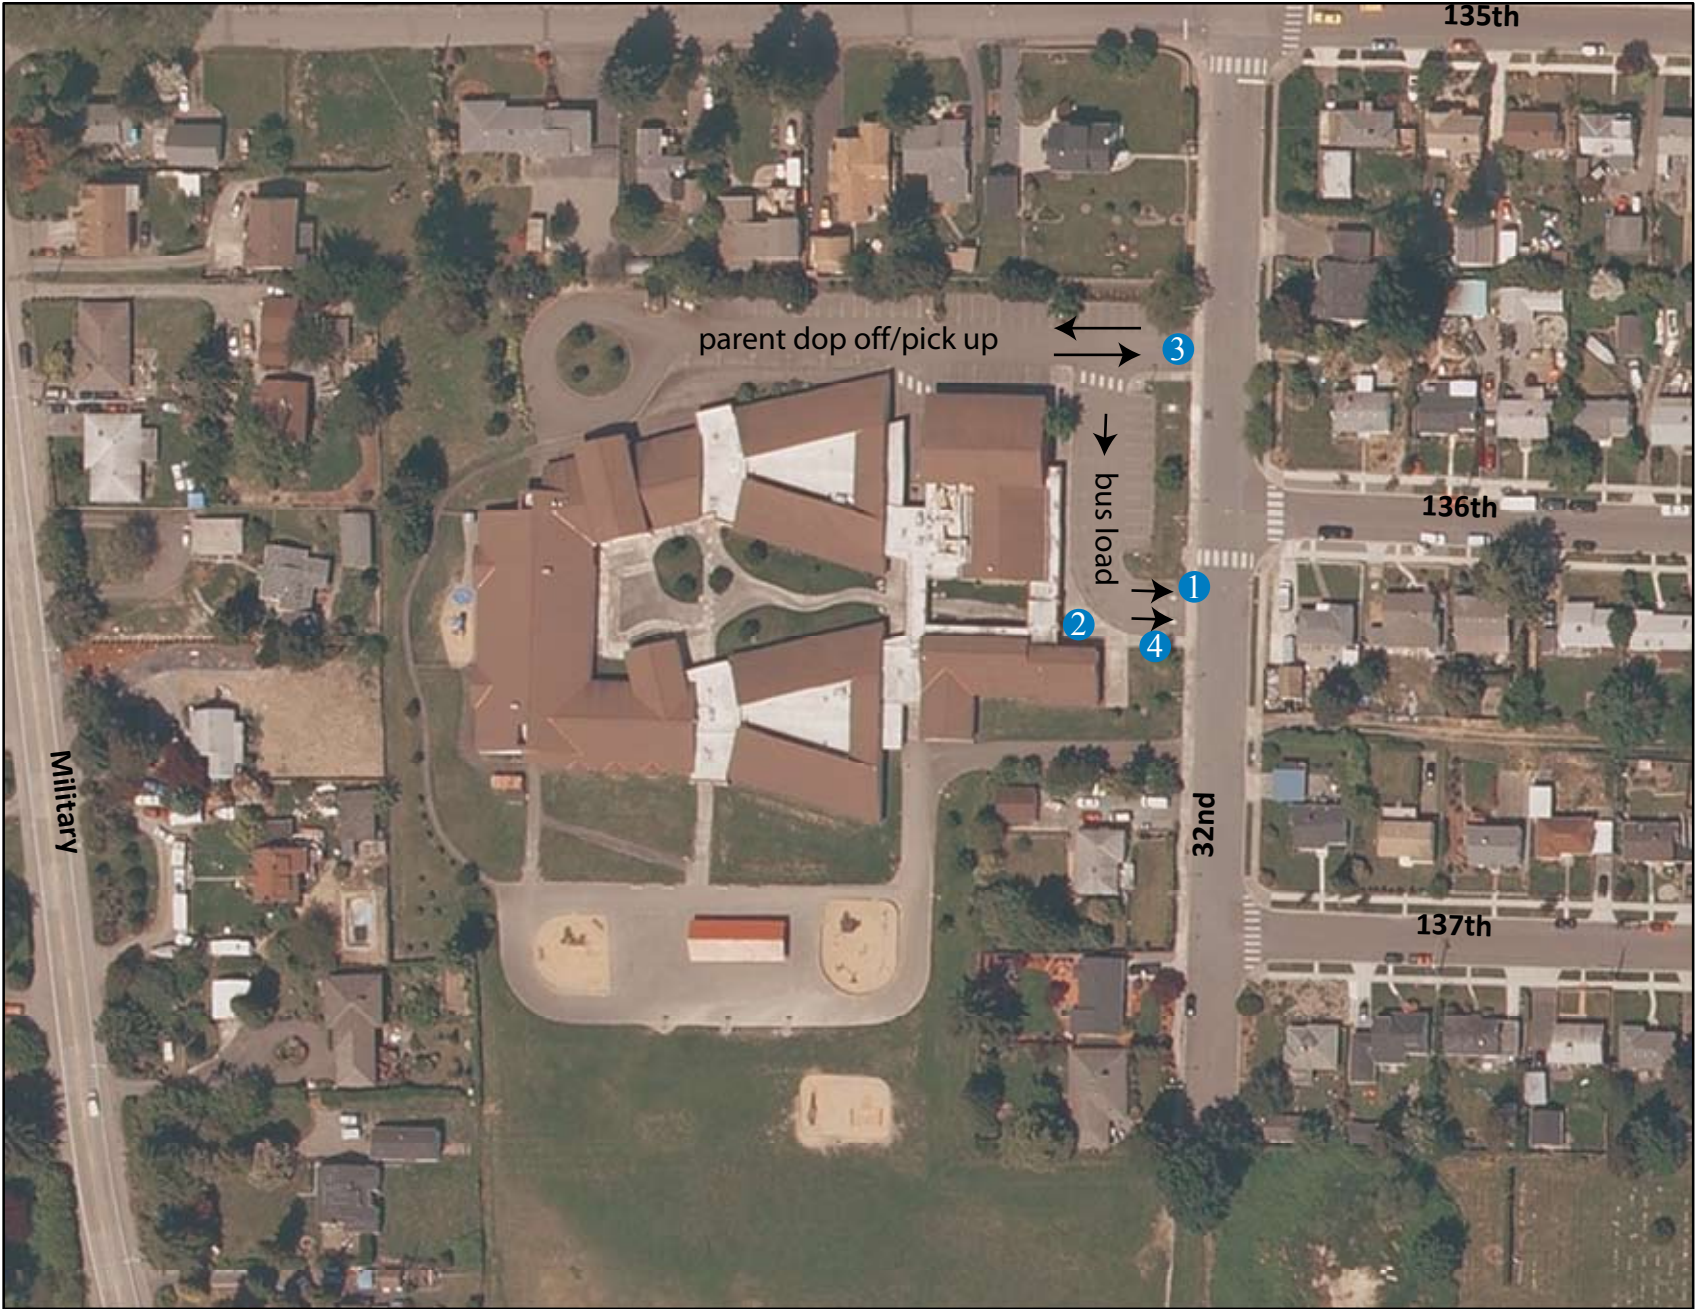
Observation Pt.	Location or Inter	Community Asset	Engineering	Enforcement	Education	Encouragement	Policy			
								Field Observations	Recommendations	Image
1	Drop off area							Extra wide curb cut for drop off area to accommodate bus and car, stop sign but no bar	Paint stop bar for cars.

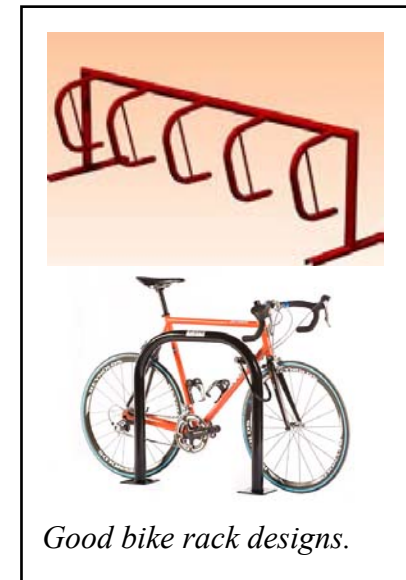
“Wheel-bender” racks (above) can damage wheels and don’t allow frames to be locked to the rack.
